Report

Genetic Characterization and QC of a CRISPRedited Cell Line

In this study, # transgenic SAMPLE with a modified Gene 1 locus was analyzed.

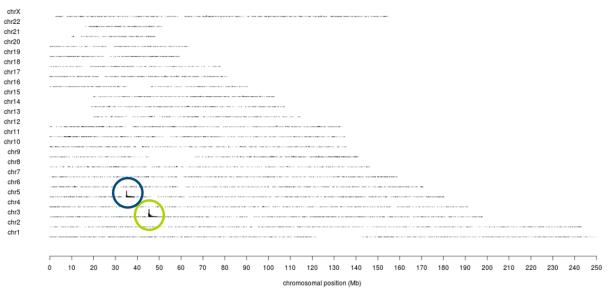
Figure 1: TLA sequence coverage across the human genome using primer set 1 (in red) and set 2 (in blue). The chromosomes are indicated on the y-axis, the chromosomal position on the x-axis. The *Gene 1* locus is encircled in green. The identified translocation is encircled in blue.

As shown in Figure 1 and Figure 2, the coverage is observed across the *Gene 1* locus on chromosome 3. Coverage is also observed on chr5 (encircled in blue in Figure 1), which indicates a translocation between chr5 and chr3 as described below. Similar results were obtained with primer set 2.

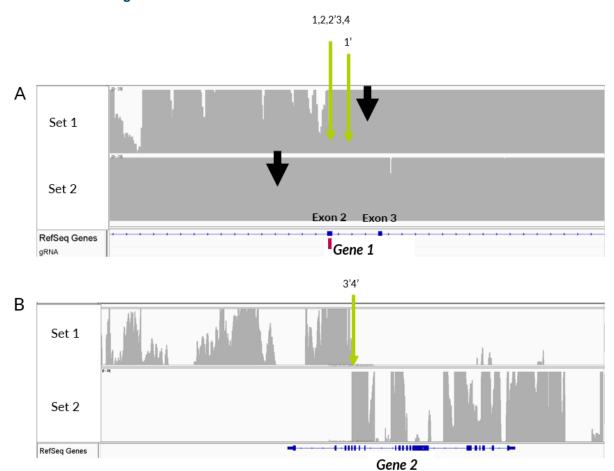
Figure 2: TLA sequence coverage (in grey) across the *Gene 1* locus on chr3 (A) and the *Gene 2* locus on chr5 (B). The black arrows represent the primer sets binding location. The green arrow indicates the location of the identified breakpoint sequences, the numbers correspond to the breakpoints described below. The red bar below *Gene 1* exon 2 indicates the sgRNA position. The Y-axes are limited to 20x.

Coverage is observed across the *Gene 1* and the *Gene 2* loci as shown in Figure 2. One-sided coverage on chromosome 5 (Figure 2B) indicates the presence of the balanced genomic translocation with Gene 1 on chromosome 3.

The following breakpoint sequences were identified marking modifications to the *Gene 1* locus. The numbers of the breakpoints correspond to the numbers in Figure 2 where (1) and (1') represent two sides of one breakpoint.

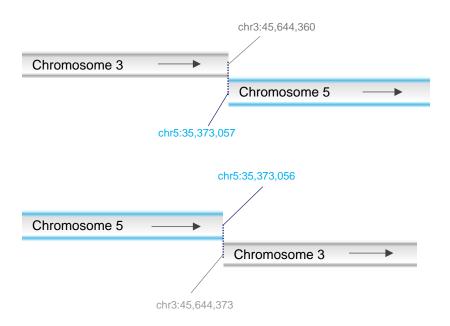
Figure 3: Schematic representation of the modified locus on the targeted allele.

From this data it is concluded that the *Gene 1* locus has been modified including the deletion of part of exon 2 and part of intron 2, and a balanced translocation with the *Gene 2* locus on chromosome 5, shown in Figure 3.
